*MJ-1027/1028*  
*Service Manual Addendum*

Supplement to the Troubleshooting  
Section

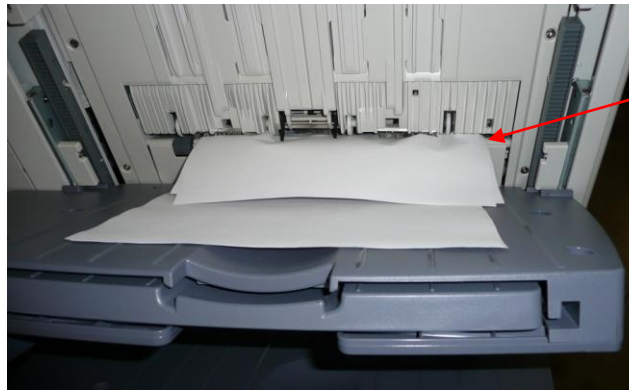
**Figure 1**

If the Escape Solenoid does not operate properly then an EA20 jam could occur (see Figure 1). The items to check for include:

- Binding of linkage
- Sticking of plunger
- Defective solenoid

Paper buckled due to guide plate not being lowered by escape solenoid

- Check for proper operation of Escape Solenoid (SL6) (part number 4402962760 SOLENOID).

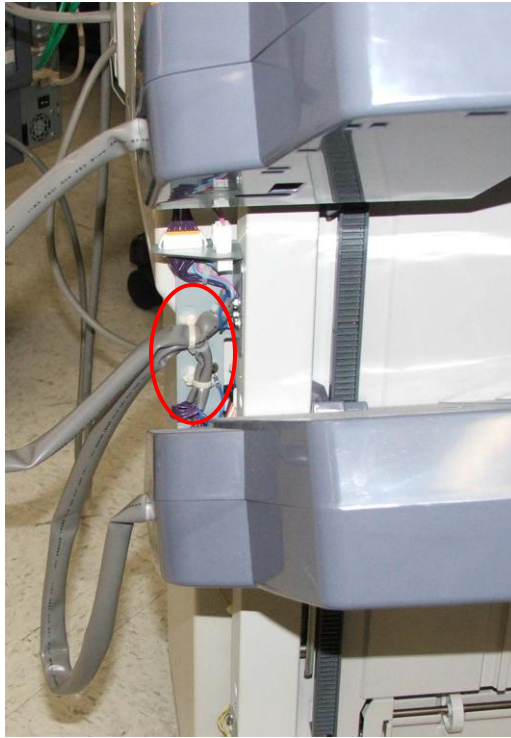
**Figure 2**

It has been noted in the field that an intermittent CB30 bin lift motor error may occur; it usually occurs when the lower bin is driving. The cause is linked to the tie wraps on the harness being too tight (see Figure 2). Over time, with the bins moving up and down, damage occurs to the harness resulting in this error. As deemed necessary, remove the cable ties. However, if the wires have already been damaged you may need to replace the harness. (upper part number: 4G30851000; lower part number: 4G30852000 CABLE-TRAY)

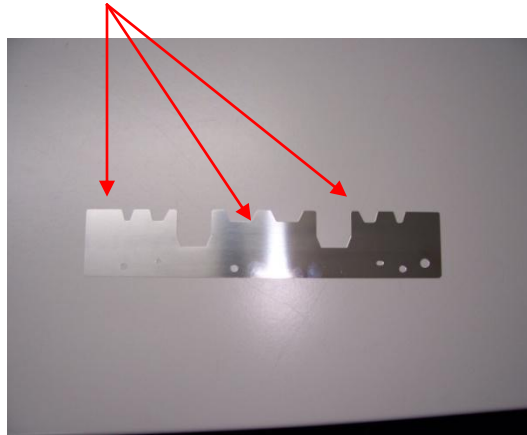
**Figure 3**

- Check the condition of the pusher plate (see Figure 3); it should be completely flat with no kinks or bends in the lead edge 'castle' areas.

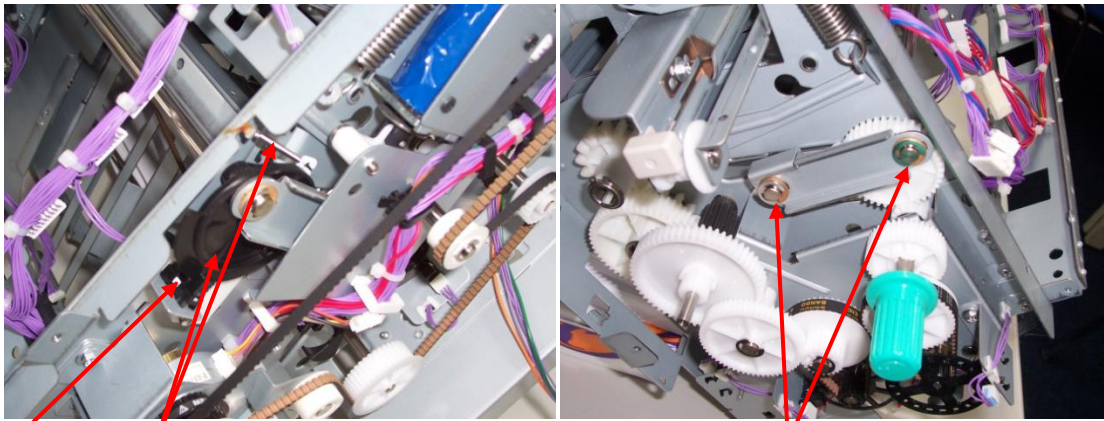
**Figure 4**

- Clean and check the pusher plate home sensor (PI15S) – do not exchange sensors in these finishers as they are not the same (see Figure 4). If you suspect the sensor is at fault, order and fit the correct sensor.

- Check the condition of the cam assembly and that the spring is still attached (see Figure 4). Also ensure that the bushings on both sides of the pusher plate assembly are in good condition and not elongated (see Figure 4).

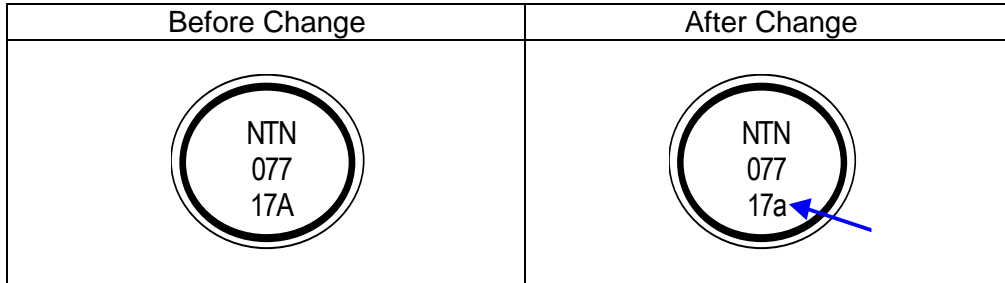
Sometimes when the paper exit tray lowers an abnormal noise can occur. To prevent the noise, the grease in the torque limiter has been changed. See the diagram below to distinguish the new torque limiter from the old one.
